**CULTURAL RESOURCES INVESTIGATIONS
RELATING TO YUCCA AND AFRICAN HOUSES,
MELROSE PLANTATION (16NA591),
NATCHITOCHES PARISH, LOUISIANA**

Final Report

2014

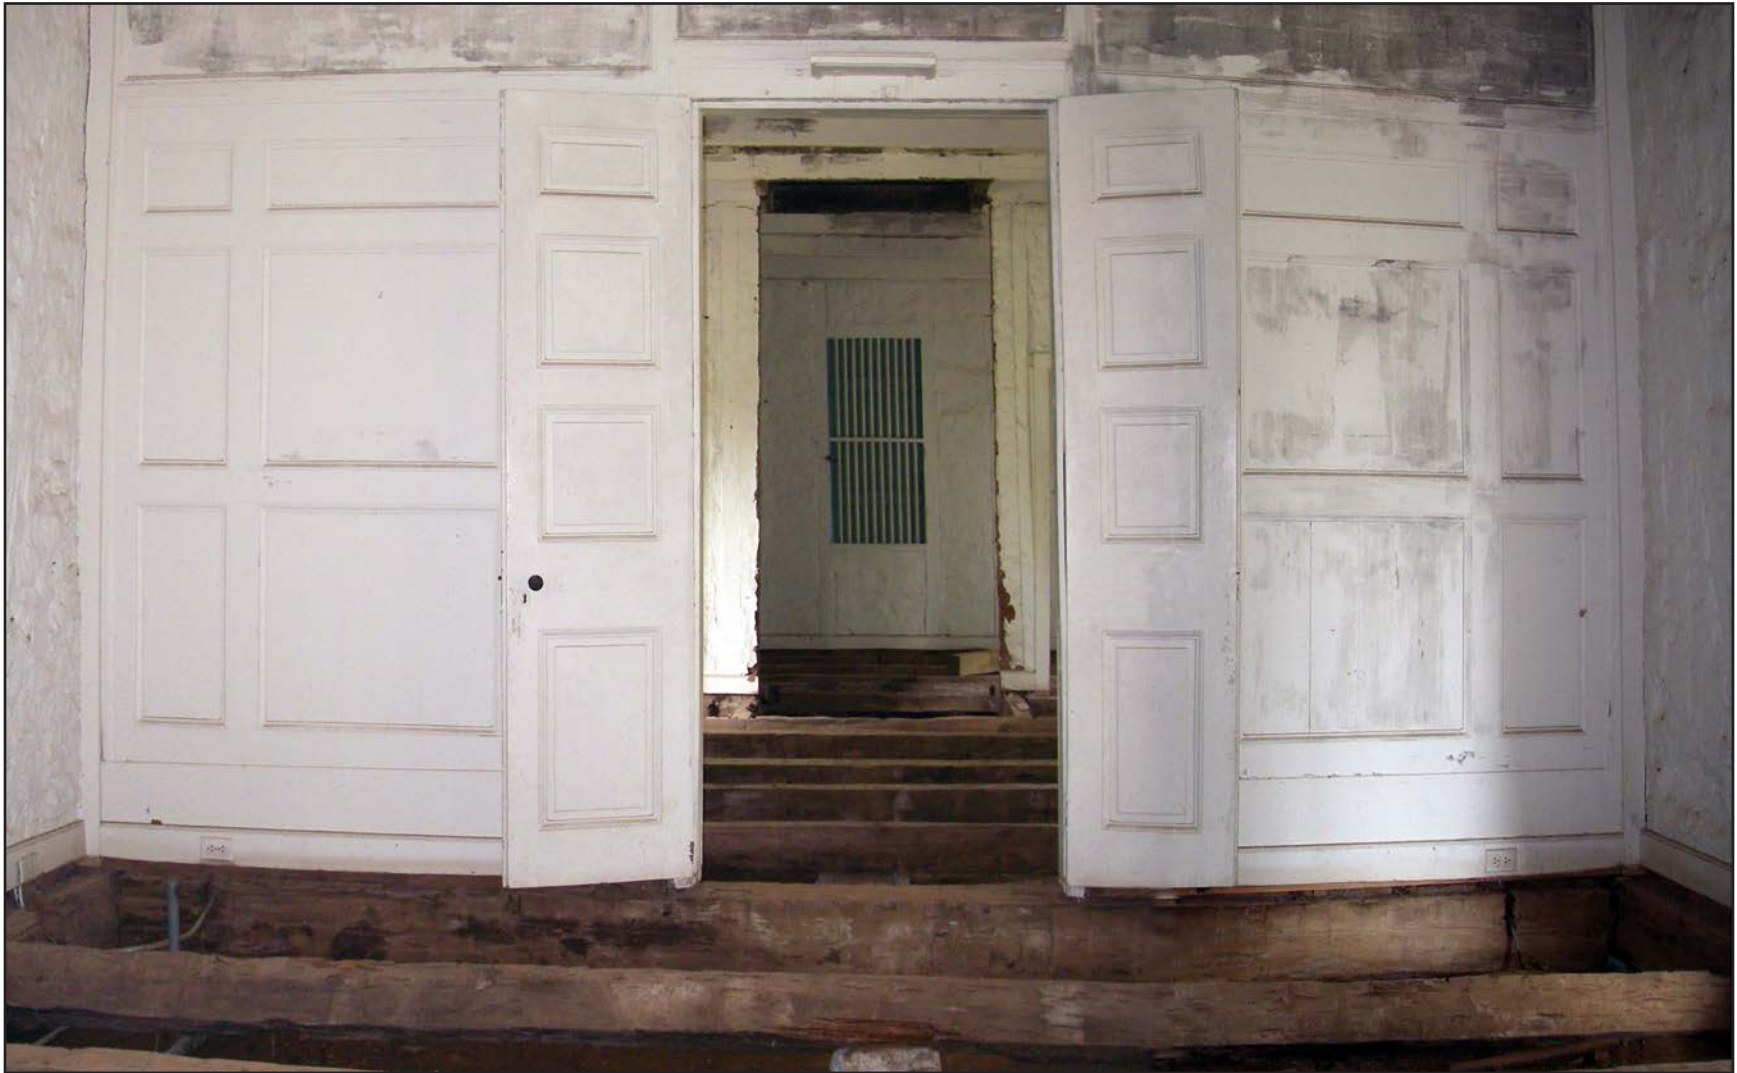
Figure 5.40. A photograph showing the interior of Yucca House at the time of the 2006-07 archaeological investigations. (View is to the west. September 1, 2006.)

As noted above, when CEI commenced the 2006-07 work at Melrose, the flooring had been removed from Yucca House as had the two fireplaces and chimneys (Figure 5.40). This allowed a chance to record the underlying structural elements in attempt to better understand the architectural history of the building.

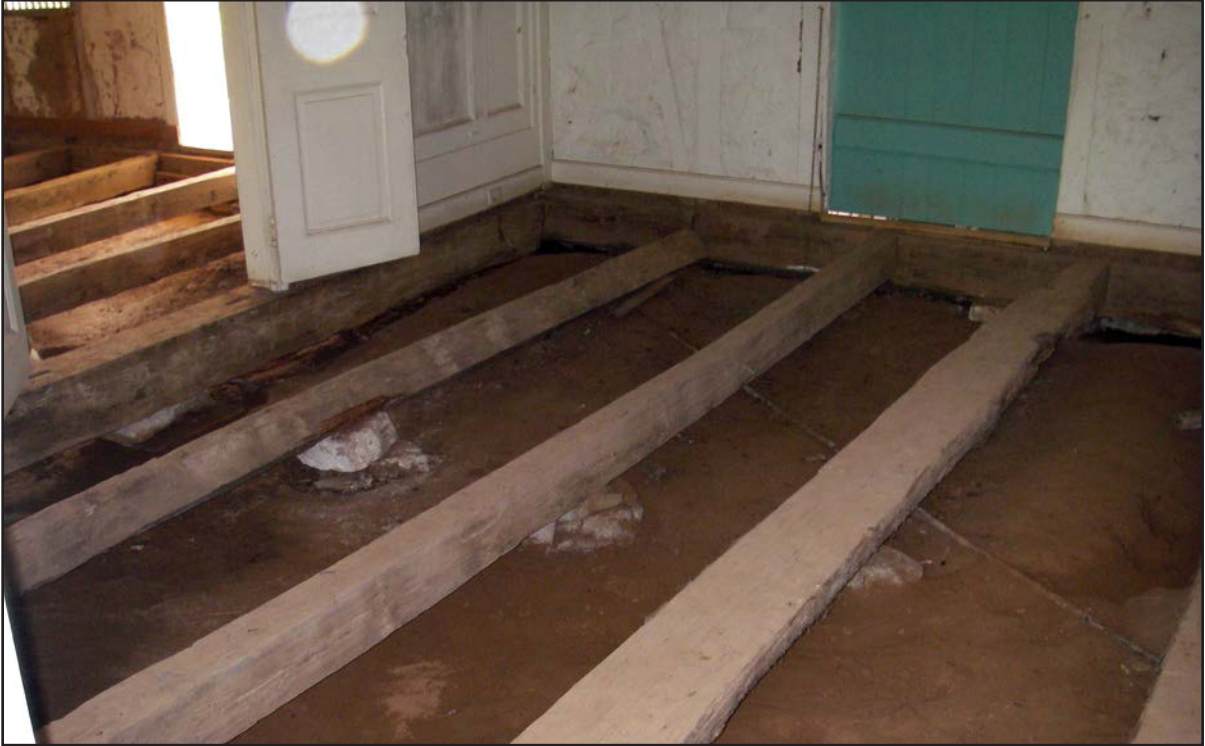
Figure 5.42. A photograph showing the original hewn cypress sills and replacement floor joists made from sectioned cypress logs in Yucca House. (Note the joists resting on sandstone and concrete blocks. View is to the south, southeast. September 1, 2006.)

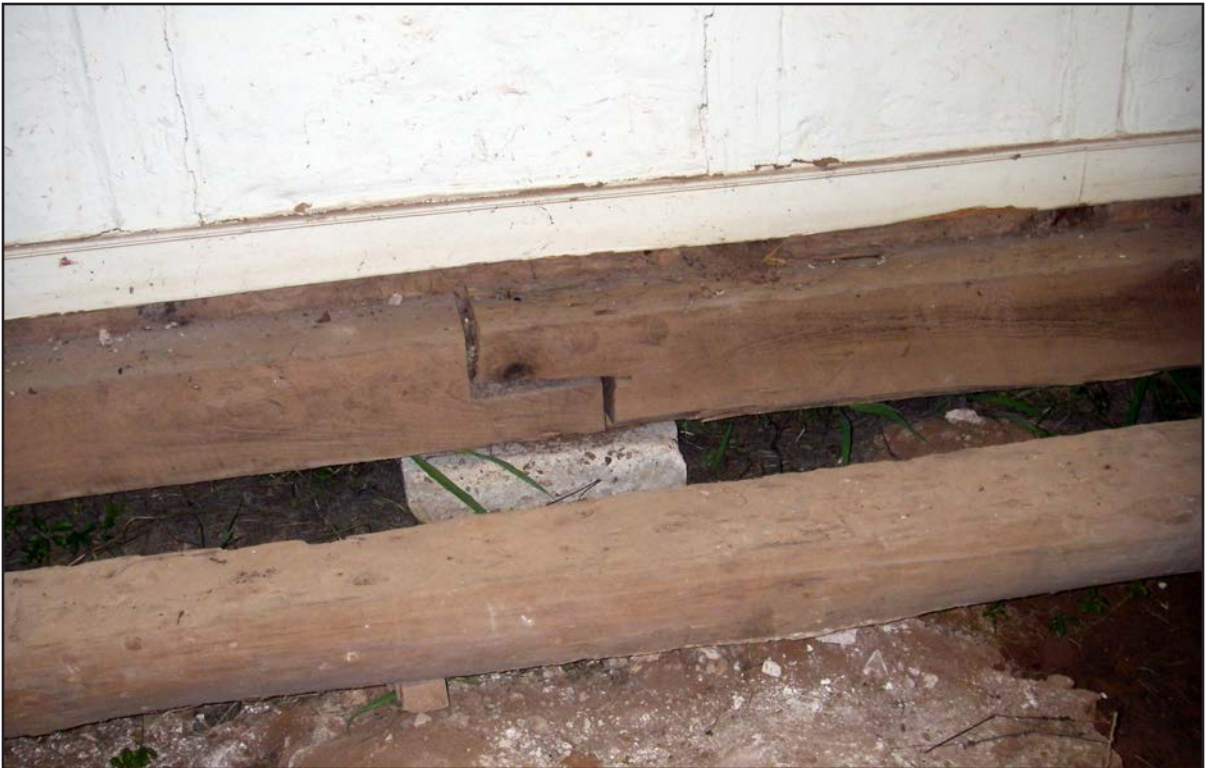
Figure 5.43. A photograph showing an exterior circular-sawn pine replacement sill and scarf joint in Yucca House. (Note the sill resting on a concrete block. View is to the west. September 1, 2006.)

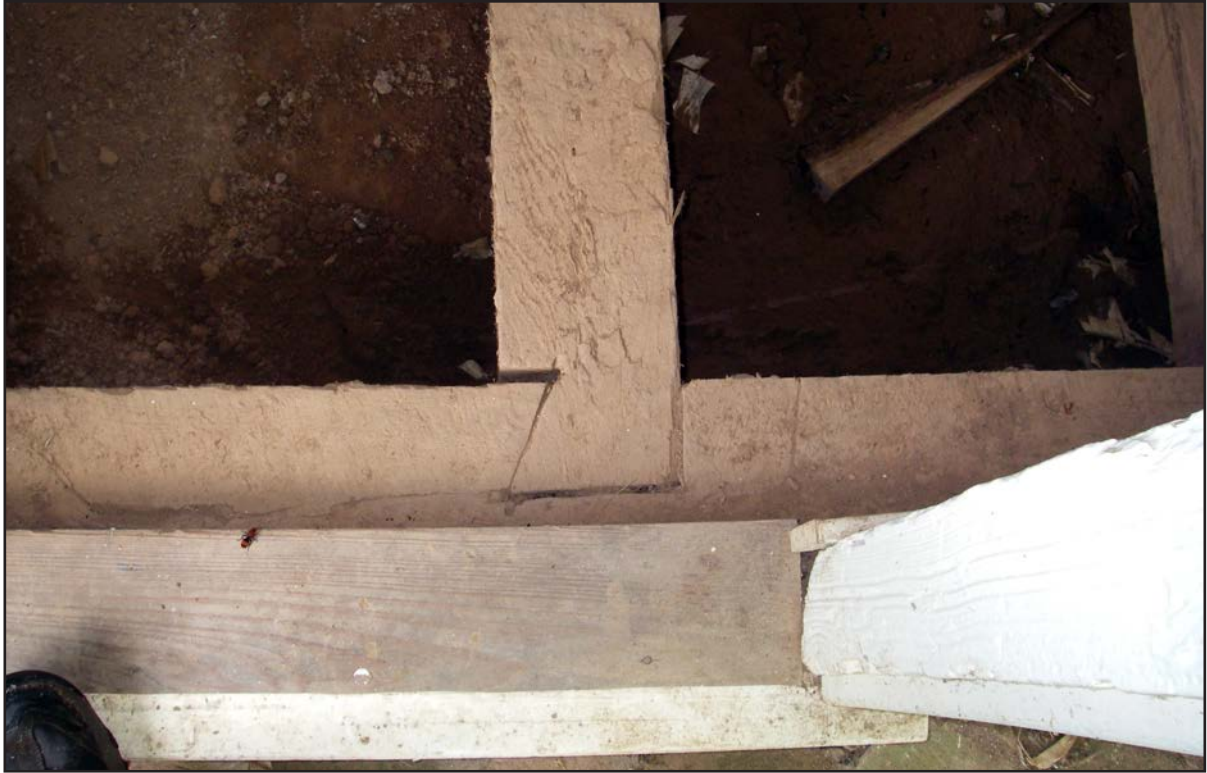
Figure 5.45 A photograph showing the circular-sawn pine replacement sills and floor joists in the north-west *cabinet* of Yucca House. (September 1, 2006.)

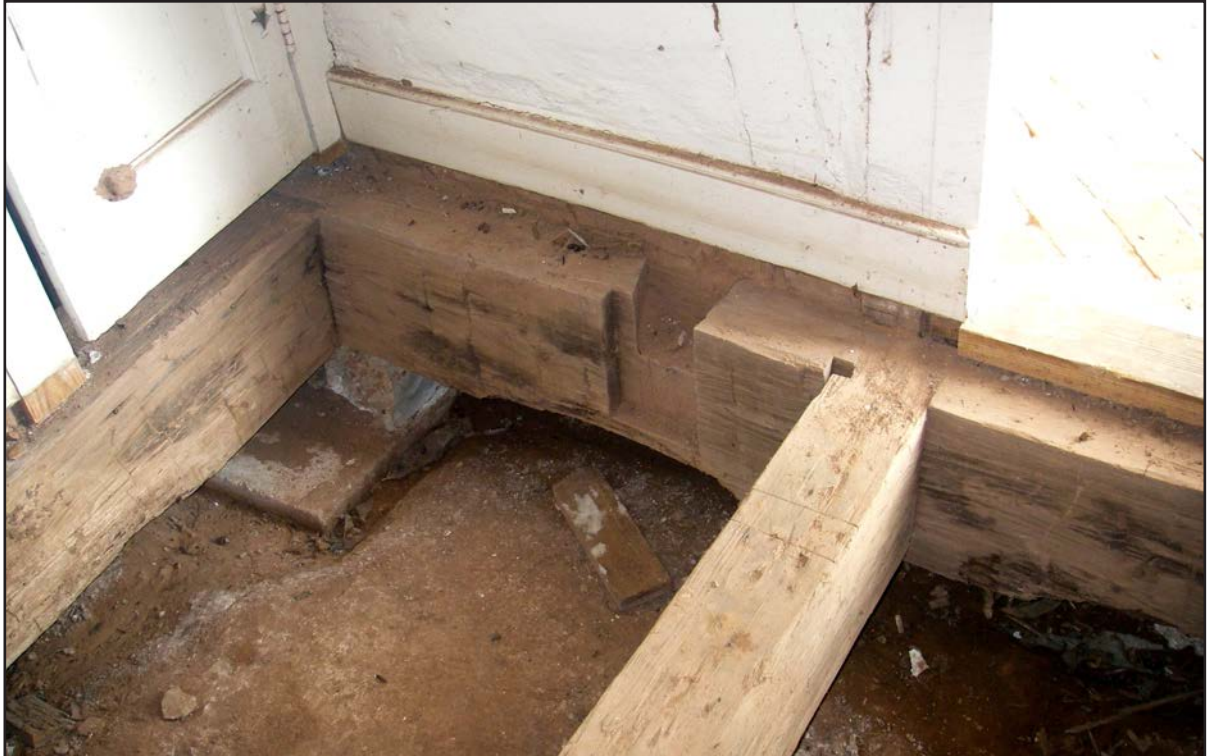
Figure 5.46. A photograph showing original cypress sills and an empty dovetailed mortise in Yucca House. (View is to the southeast. September 1, 2006.)

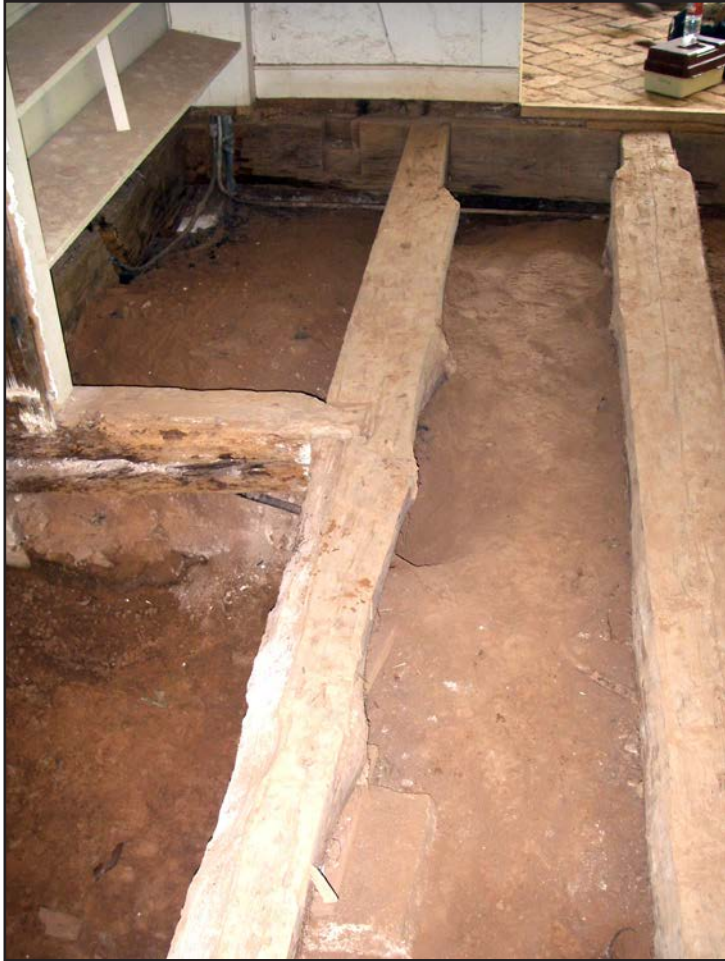
Figure 5.47. (Left) A photograph showing the replacement joists fashioned from sectioned cypress logs in Yucca House. (View is to the north. September 1, 2006.)

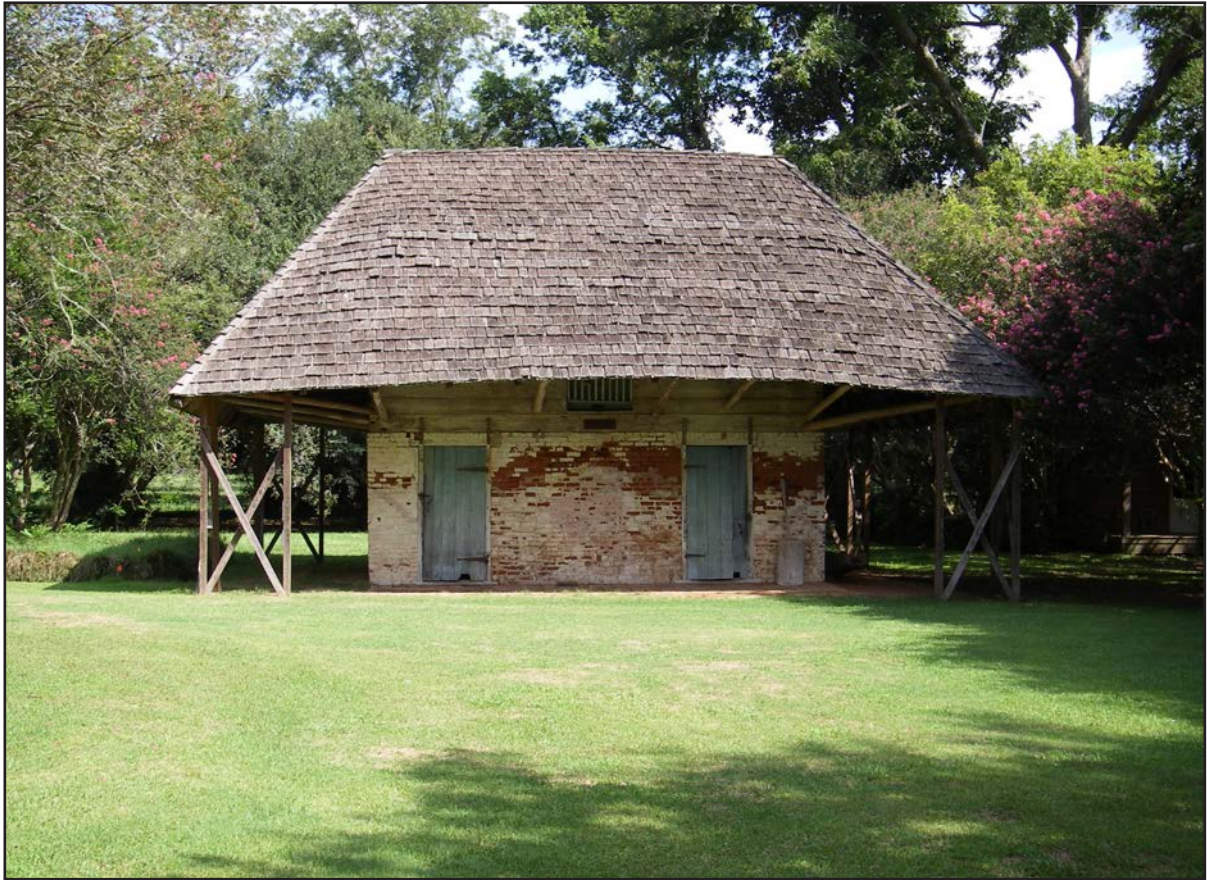
Figure 5.49. A photograph showing the front of African House. (View is to the north. September 1, 2006.)

resemblance to native houses in some parts of Africa having high-pitched hipped roofs covered with thatch. This is a two-story building, the lower portion made of brick. The brickwork supports an upper pen constructed of tightly fitting hewn dovetailed cypress timbers. A steeply pitched hipped roof covered with cypress shingles almost completely obscures the upper pen from view. An interesting element of this building is the absence of columns or posts around the perimeter to support the outer edge of the roof. (Note that the wooden braces shown in Figure 5.49 were recent additions to support the edges of the roof to prevent sagging.)

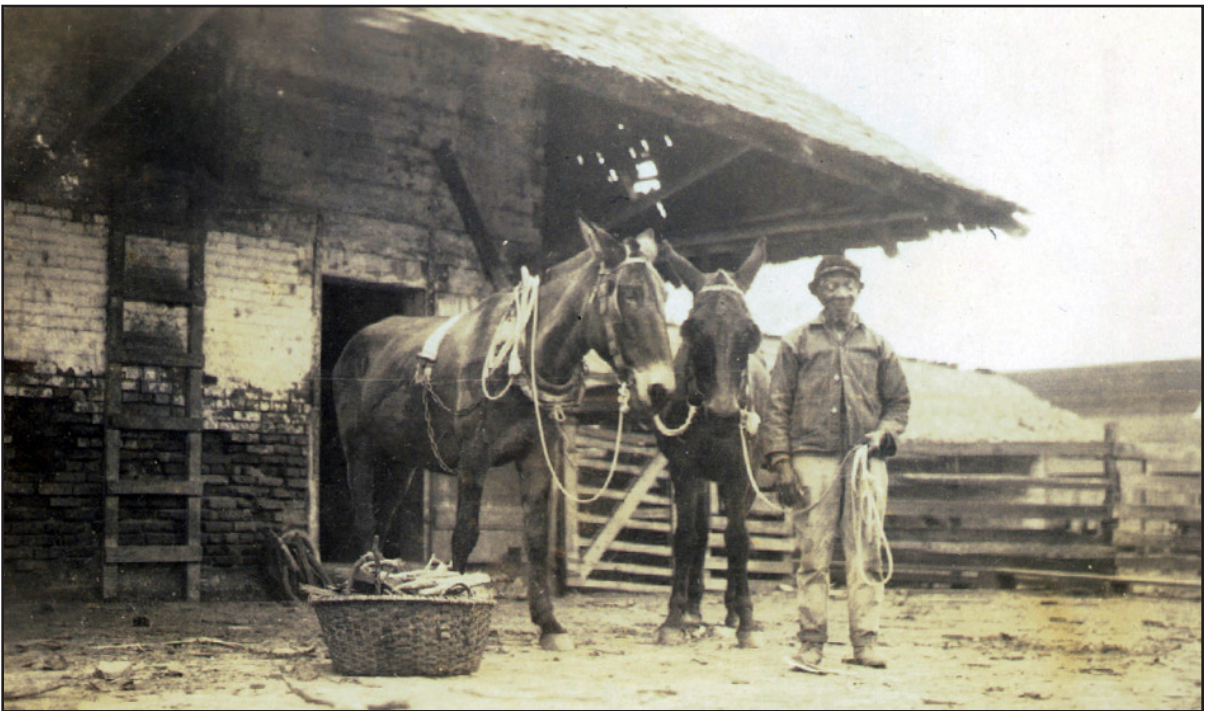
Figure 5.51. An undated photograph showing the front of African House (CGHRC, Melrose Collection, Scrapbook 79, p. 30, photograph 3).

The second photograph in this set (Figure 5.51) is undated and shows only a portion of the front of the building and illustrates some of the architectural elements described above. A man holding the reins of two mules suggests the possibility that the structure was then being used as a stable. The white oak basket of unshucked corn in the foreground could be interpreted as meaning the upper pen of the building was then being used to store corn or hay used as livestock feed.

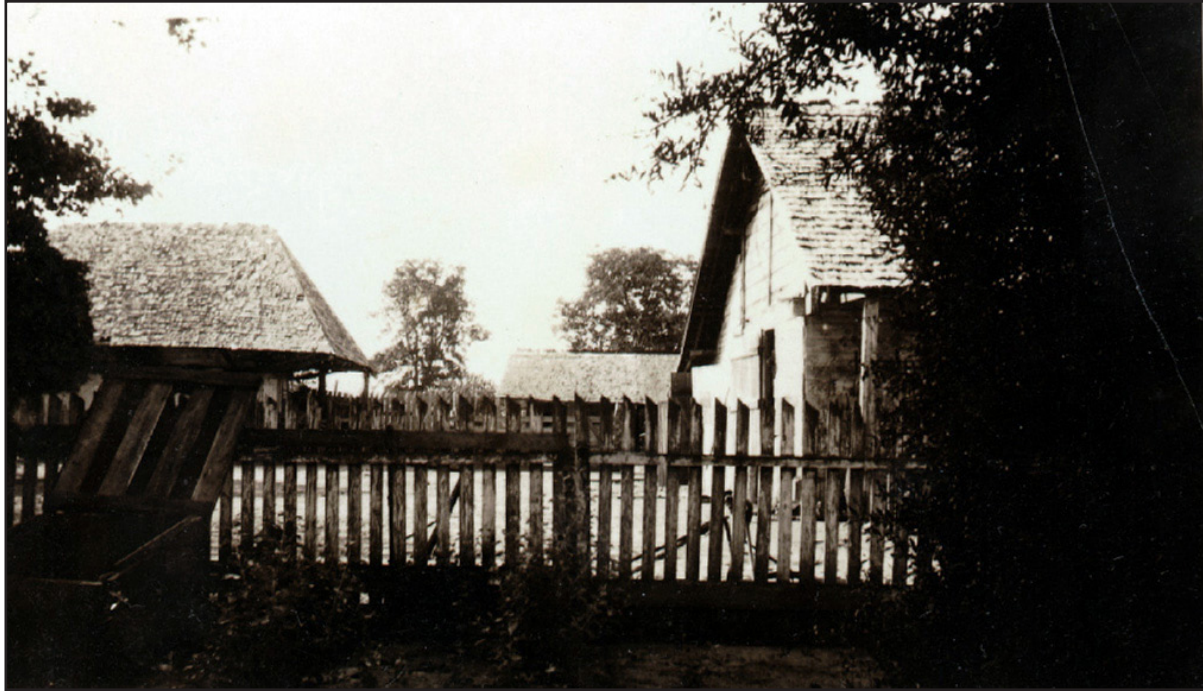
Figure 5.52. An undated photograph showing parts of the barn (right), Writer's Cabin (rear center) and African House (left) (CGHRC, Melrose Collection, Scrapbook 71, p. 55 photograph 2). (Note the corner posts supporting the outer roof line of African House.)

In the first two images, only a part of the roof was visible. In the third photograph (taken from the vicinity of the present Bindery location) (Figure 5.52), a greater portion of the roof can be seen, as well as a part of the barn and the Writer's Cabin. The undated photograph is of particular interest as it shows what appear to be posts supporting the corners of the roof.

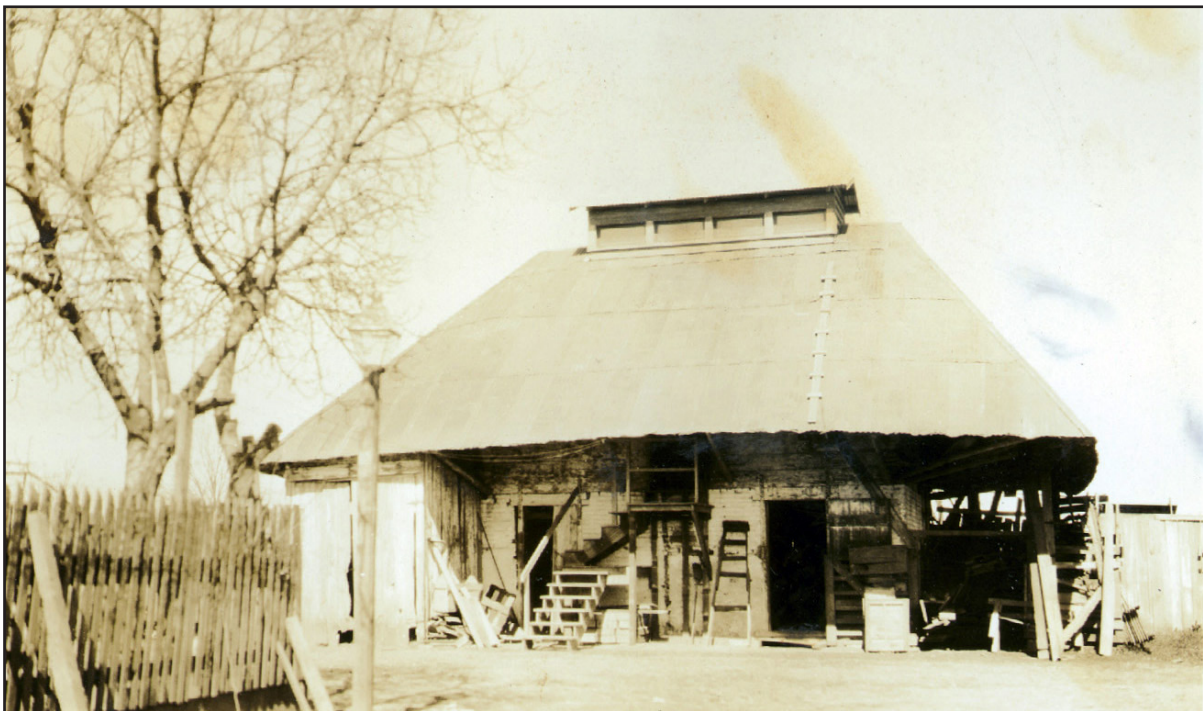
Figure 5.53. An undated photograph showing the front of African House (CGHRC, Melrose Collection, Scrapbook 83, p. 1, photograph 1).

A fourth photograph dated 1929 (Figure 5.53) is evidently somewhat later than the three discussed above. It shows that the cypress shingles had been replaced by corrugated metal sheeting, and that a combination skylight/roof vent with four glass panes had been added. The ladder leading to the opening in the upper pen had been replaced by wooden stairs. The shed-like enclosure remained on the western side of the structure, but the livestock holding pen on the eastern side had been removed. The image seems to show large vertical posts or timbers supporting the outer edge of the roof along its eastern side.

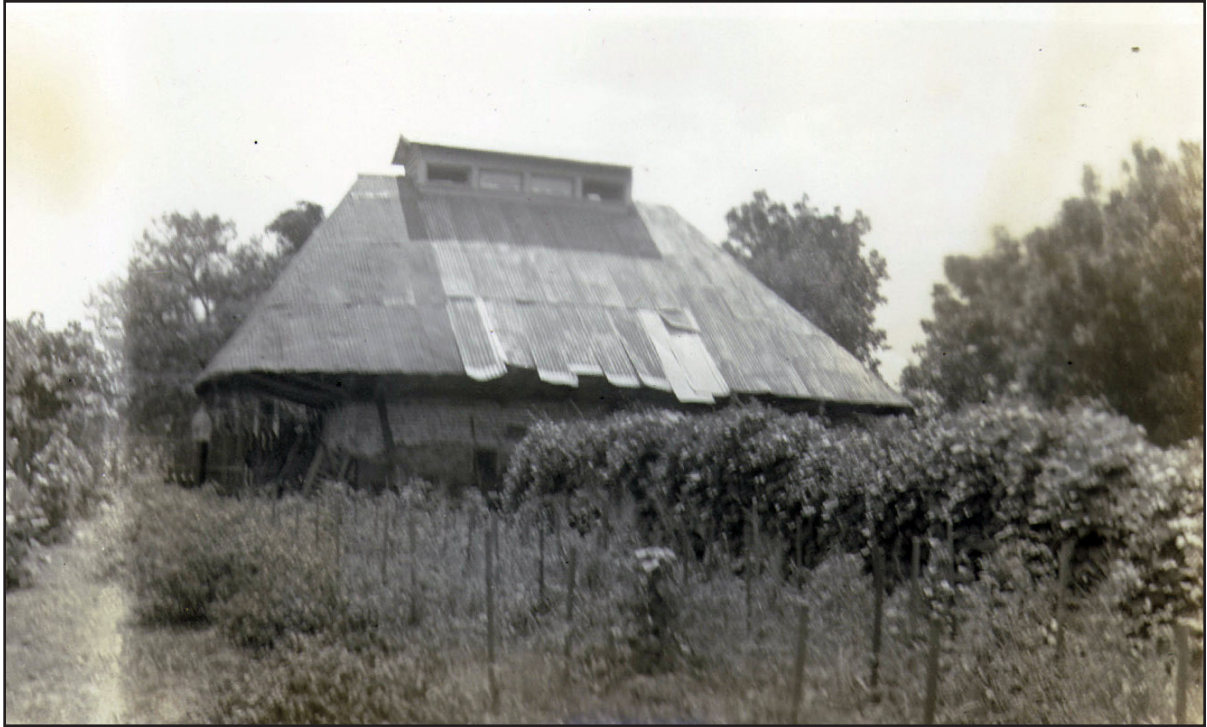
Figure 5.54. A ca. 1934 photograph showing the rear of African House (CGHRC, Melrose Collection, Bound Volume 171).

All of the early photographs of African House illustrate its front or southern side. The single exception (Figure 5.54) is a rather poor-quality image that shows possible repairs to the metal roofing. A small opening can be seen in the rear of the building on its eastern margin; it appears to have been half the height of the brick wall and seems to have extended to the ground, serving as a small entrance or doorway. The opposite (western) side of the rear wall is obscured by vines growing in the foreground.

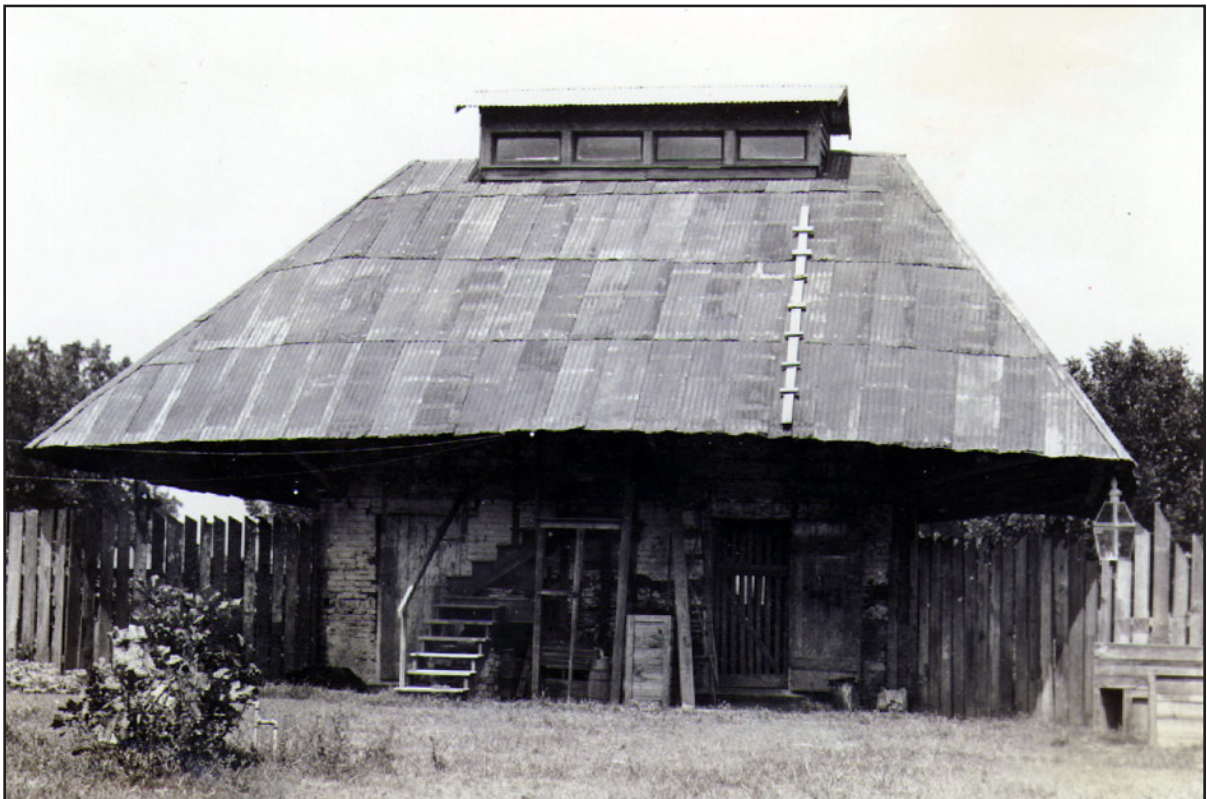
Figure 5.55. A ca. 1934 photograph showing the front of African House (CGHRC, Melrose Collection, Bound Volume 171).

Two photographs thought to date ca. 1934 (Figures 5.55-5.56) show that the enclosure on the western side of African House had been removed and replaced by a wooden picket fence, as had the former livestock catch pen on the eastern side of the building. A gas or electric pole-mounted lamp (similar to the one in several early images of Yucca House) had been installed. What appears to be a gate made of wooden slats is visible in the doorway on the eastern side of the front wall. The stairway continued to be used for access into the second story pen. Many of these same fea-

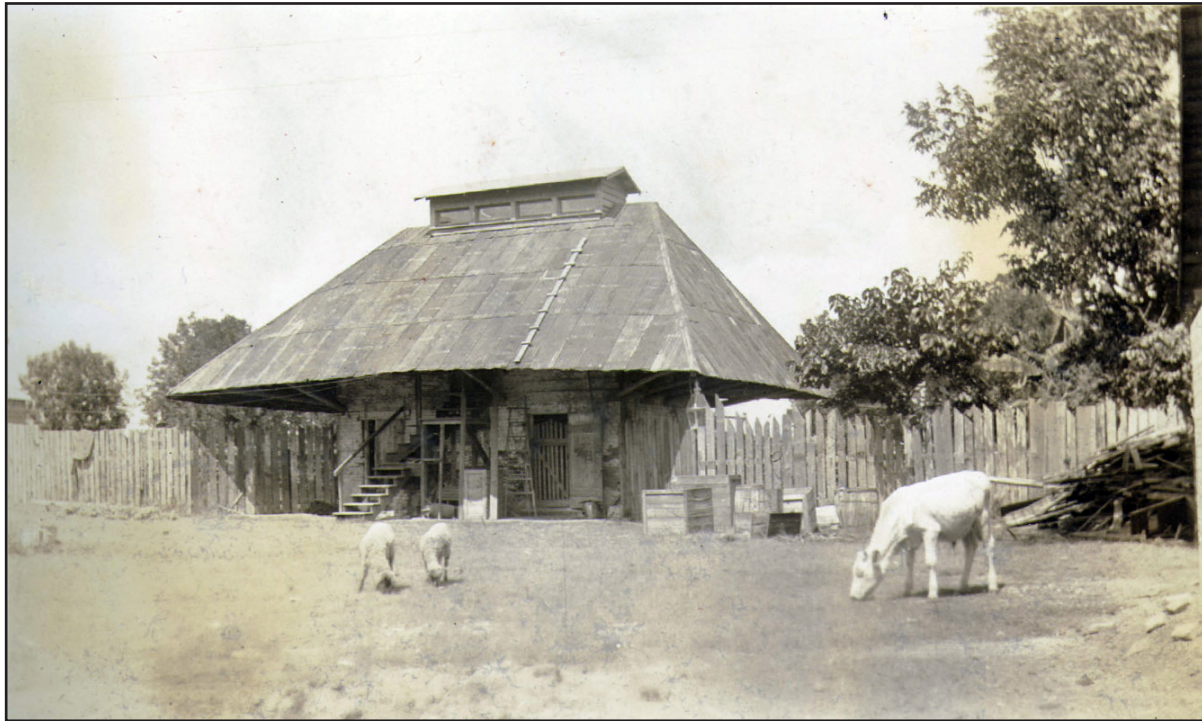
Figure 5.56. A ca. 1934 photograph showing the front of African House (CGHRC, Melrose Collection, Bound Volume 182).

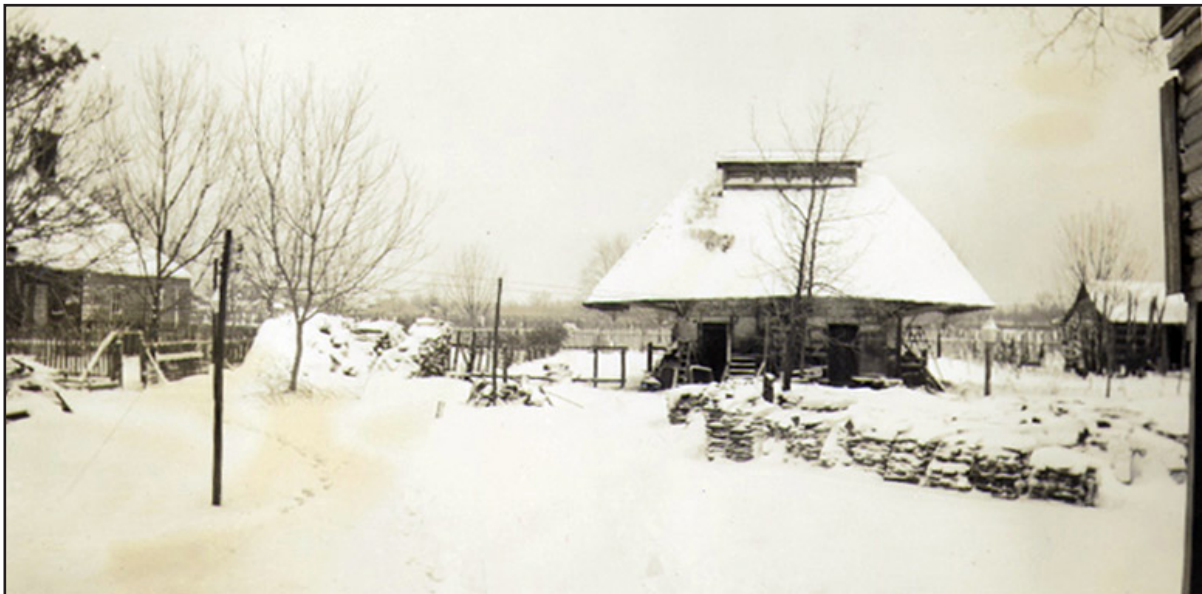
Figure 5.57. A ca. 1934 photograph showing the front of African House (CGHRC, Melrose Collection, Bound Volume 182).

tures are shown in a photograph from Cammie Henry's 1934 journal that shows the African and Yucca houses covered in snow (Figure 5.57).

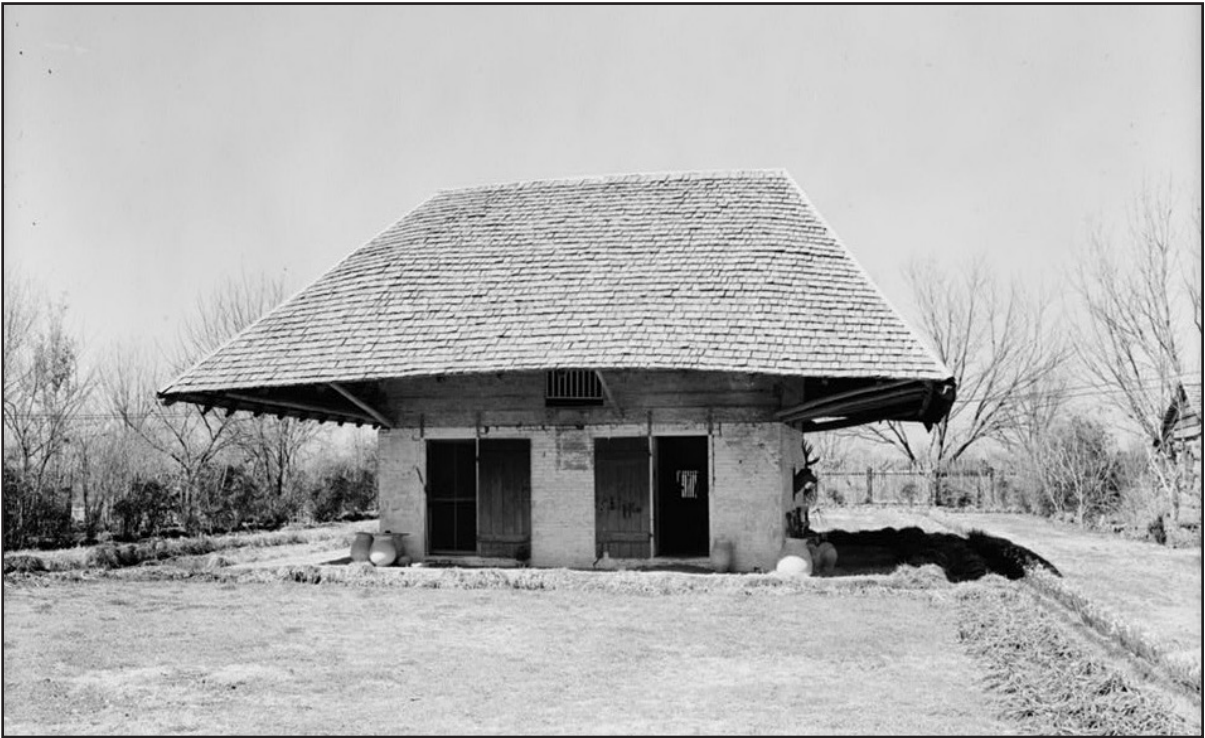
Figure 5.58. A February 28, 1940, Historic American Buildings Survey photograph showing the front of African House (Library of Congress, Historic American Buildings Survey, LA, 35-MELRO 1 B-1).

A photograph of African House was taken by Adolph H. Fendler for the Historic American Buildings Survey in 1940 (Figure 5.58). It shows that substantial changes had been made to the structure over the previous six years. The combination skylight/roof vent had been removed. The corrugated metal roof had been replaced with cypress shingles. Additionally, the exterior stairway had been removed, and bars had been placed across the opening centered in the outer wall of the second story pen. Finally, the swings of the board-and-batten doors had been reversed, and interior screen doors had been added. Fendler's notes accompanying this photograph indicated that the shingle roof was new and that the ground-level floor was originally dirt but had recently been paved with brick. An interior stairway had been added, as well as a stairway partition. The wooden flooring in the upper story was also new (Fendler 1940).

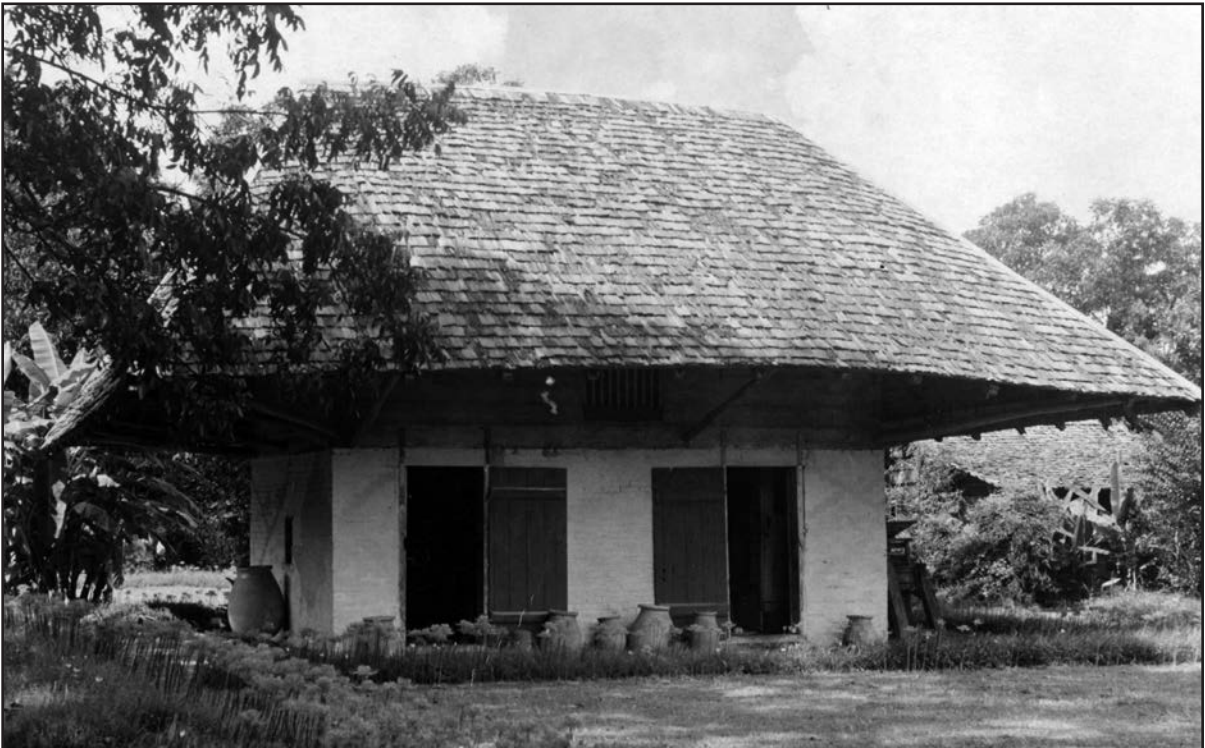
Figure 5.59. An undated photograph showing the front of African House (Louisiana Digital Library, Louisiana State Library, Image No. hp005232).

An undated photograph of African House obtained from the Louisiana State Library possibly dates to the 1950s (Figure 5.59). It shows no major changes in the structure since 1940. In 1955, the upper story of African House was converted into a gallery displaying the artwork of Clementine Hunter. The downstairs was used as a museum to house relics pertaining to the history of the plantation and the Cane River Area (*The Advocate* 1955:19).

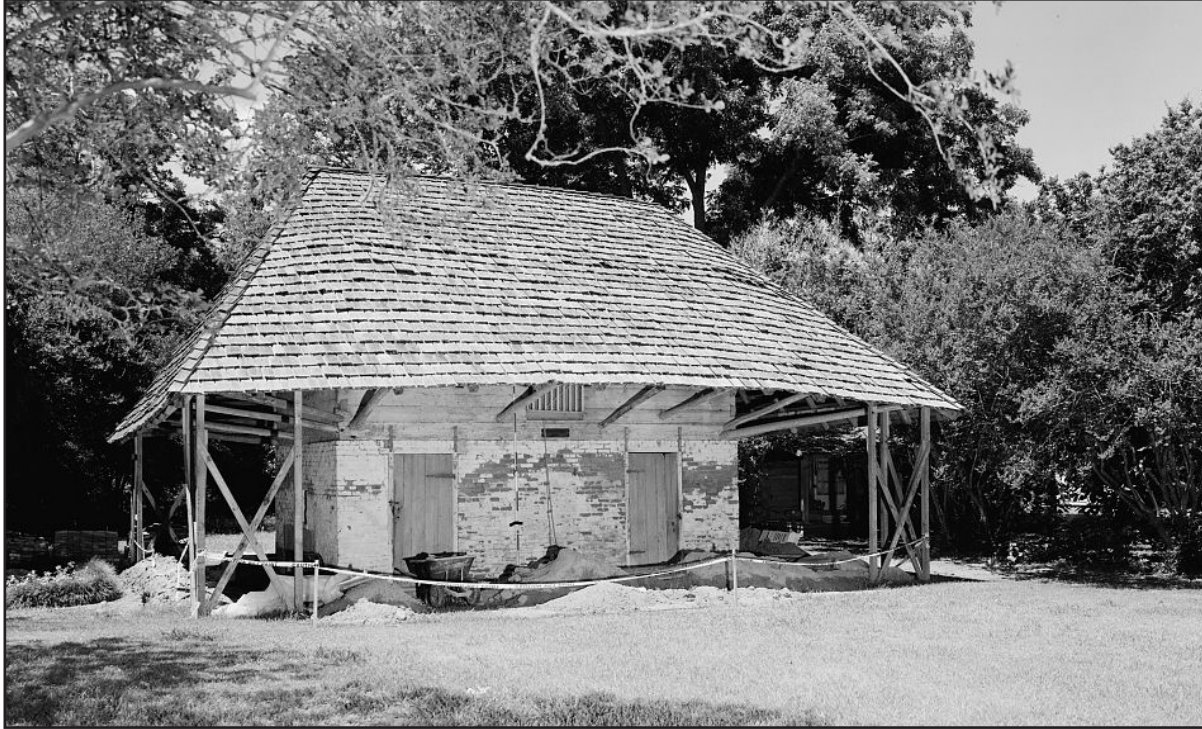
Figure 5.60. A 1980 Historic American Buildings Survey photograph showing the front of African House during the Wilson and Koch restorations (Library of Congress, Historic American Buildings Survey, LA-2 -69-B-6).

The final photographs of African House discussed herein were taken in 1980 during the most recent restorations of the building. These images are among several HABS photographs of African House maintained at the Library of Congress. All show large-scale dirt removal from the outer perimeter of the building along the base of the brick wall (Figures 5.60-5.61). A close-up view illustrating the work done on the front of the building (Figure 5.62) shows a shallow trench excavated along the front wall with what appears to be pieces of structural steel supported by a poured-in-place concrete pad inserted under the outer brick wall. It does not appear that the wall had been originally built with masonry spread footings, which probably would have limited or prevented settling. When these restorations were taking place, remnants of an interior brick wall were uncovered. That wall ran north-south and divided the lower story into two equal-size rooms (Hiram F. Gregory, personal communications, September 1, 2006).

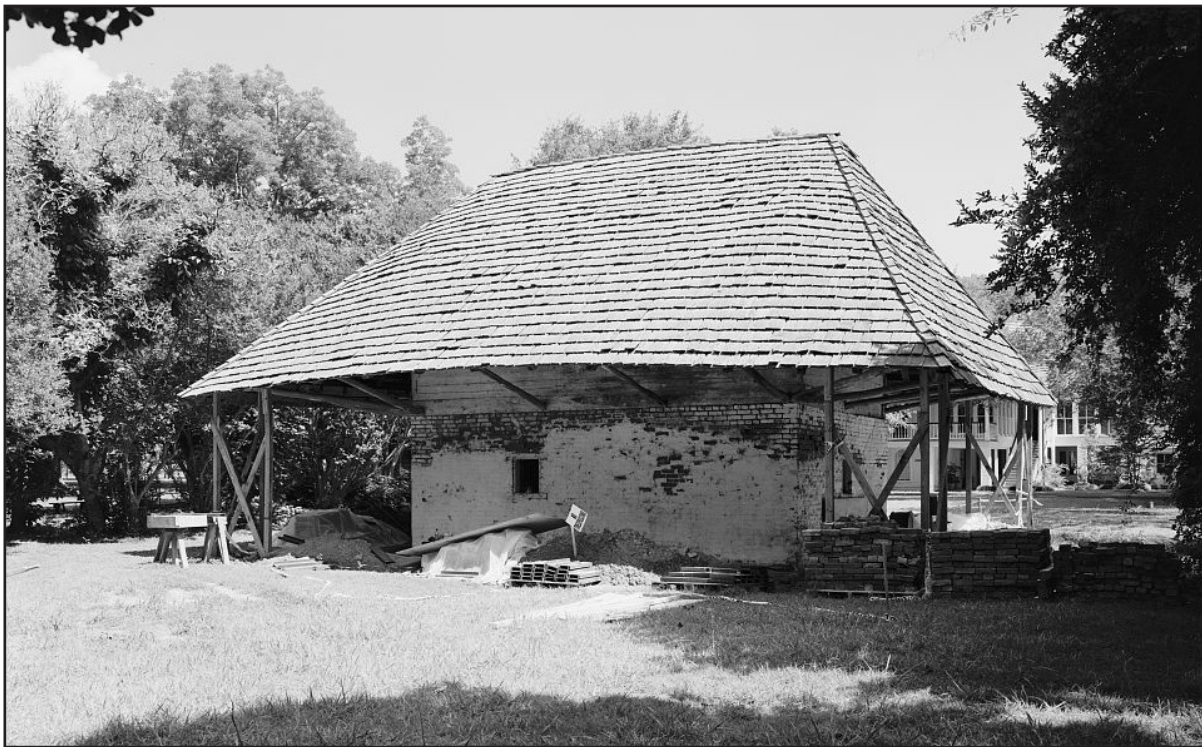
Figure 5.61. A 1980 Historic American Buildings Survey photograph showing the rear of African House during the Wilson and Koch restorations (Library of Congress, Historic American Buildings Survey, LA-2 -69-B-10).

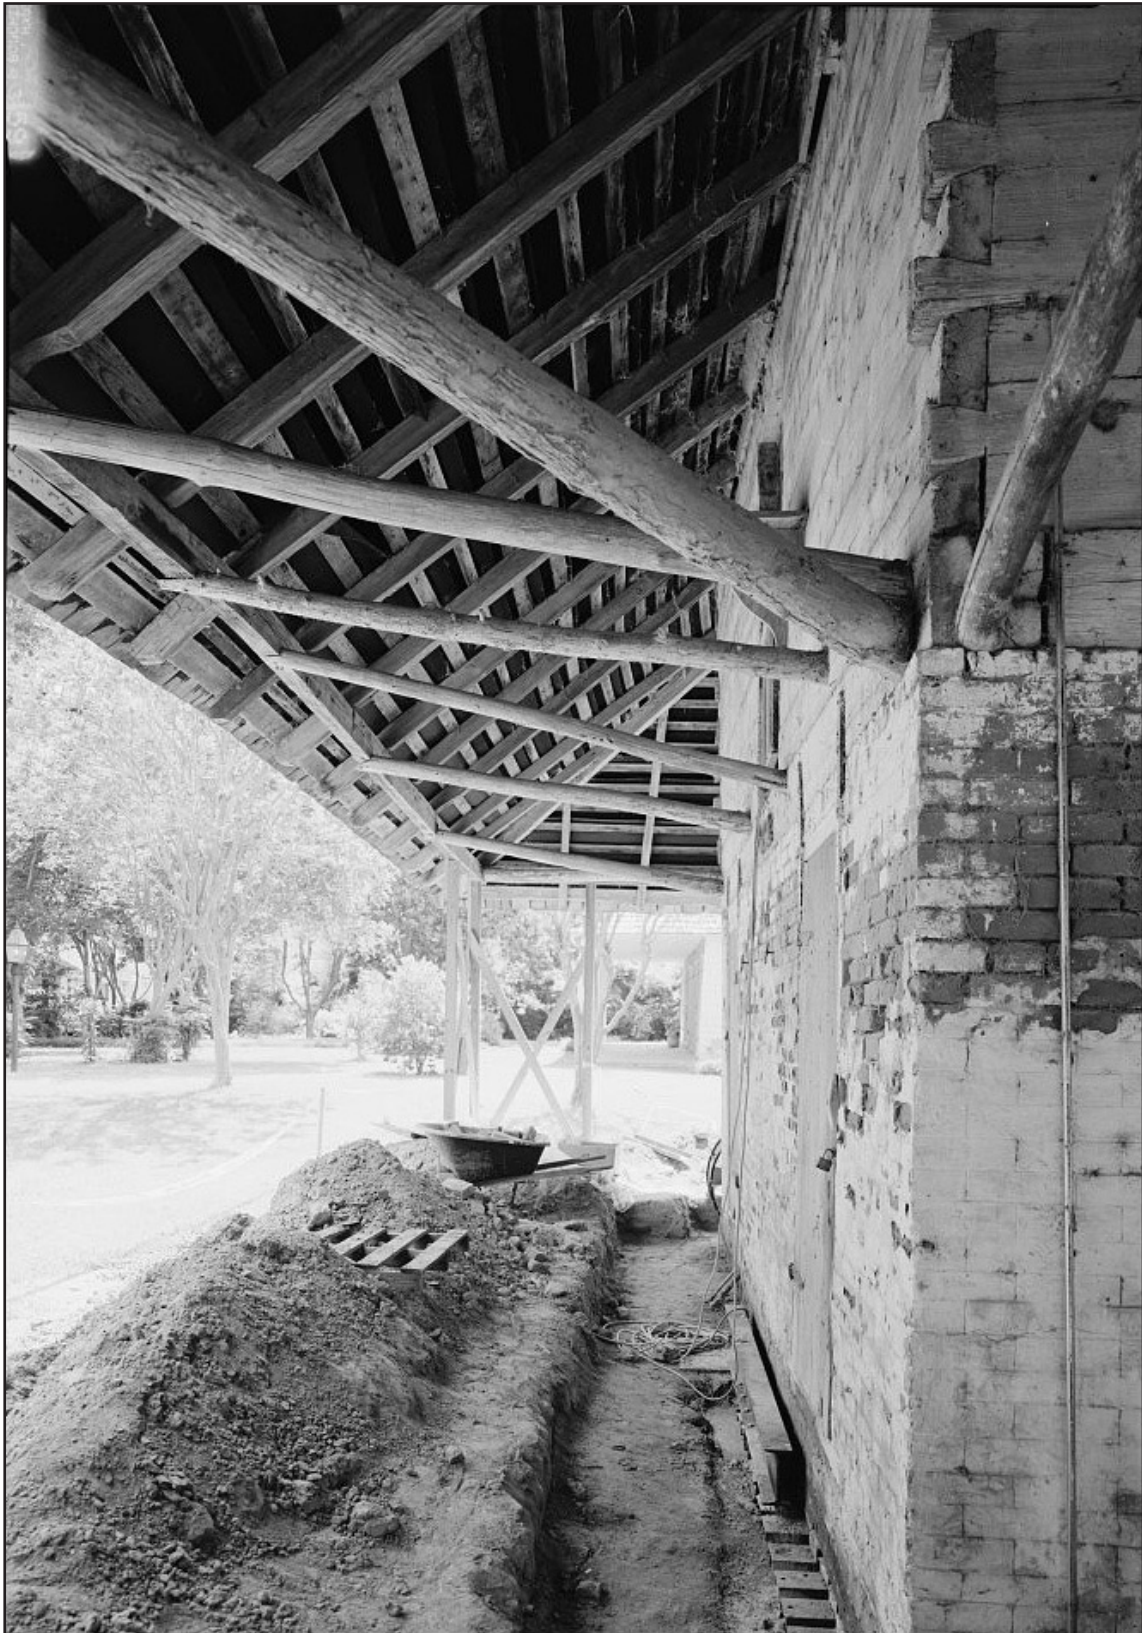
Figure 5.62 A 1980 Historic American Buildings Survey photograph showing details of the construction in front of African House during the Wilson and Koch restorations (Library of Congress, Historic American Buildings Survey, LA-2 -69-B-8).

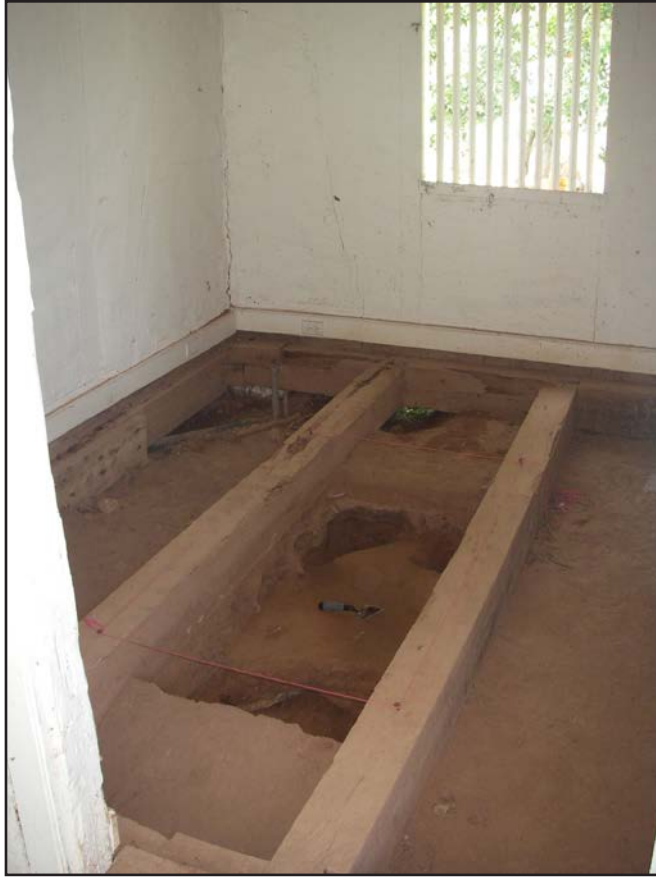
Figure 6.17. (Left) A photograph showing Unit N in the southwestern *cabinet* of Yucca House completely excavated. (View is to the west, southwest. September 7, 2006.)

Feature 4 was in the northwestern corner of Unit N (see Figure 6.16). Its matrix was similar to the others and consisted of a reddish brown (5YR 4/3) silt containing some ash and charcoal. When its fill was removed, Feature 4 extended down a maximum of 52 cm below the unit datum (see Figures 6.17-6.19).

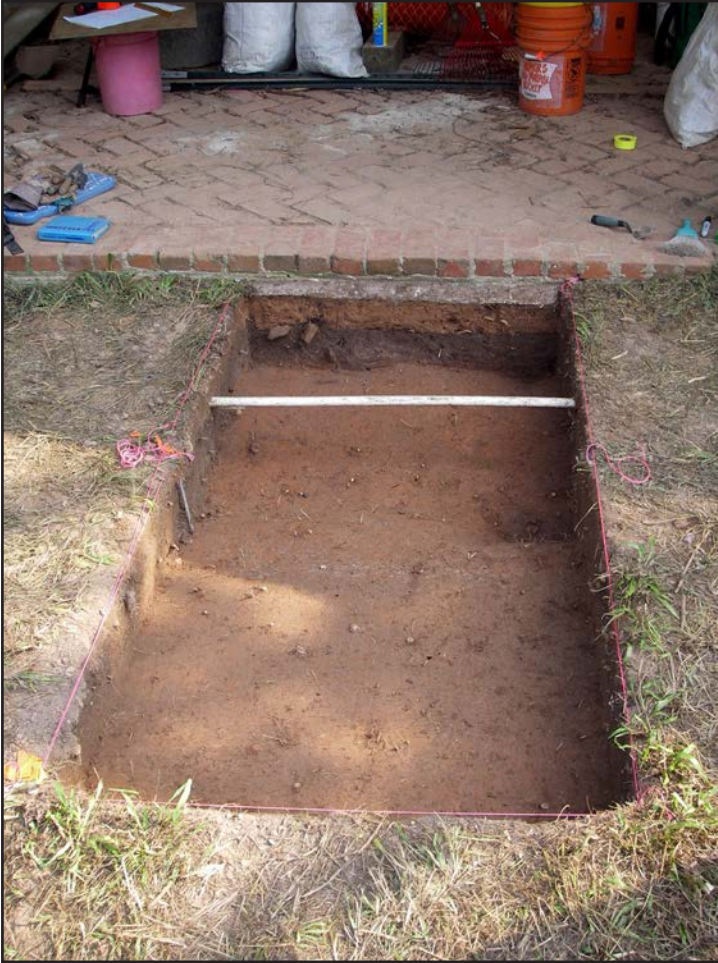
Figure 6.24. (Left) A photograph showing Units N5014-N5015 E4944 completely excavated. (View is to the south. September 7, 2006.)

The ashy character of the two central zones suggested these were a part of the feature previously encountered in Unit G. As such, these two were treated as a single entity and removed as one unit from both of the two excavation units (Figures 6.24-6.26). Feature 1 only extended down an additional 10 cm and appeared in profile as a shallow depression measuring 85 cm wide. It was linear in nature and corresponded to the outer roof line of Yucca house, suggesting it represented the drip line of the structure.
